Tank 4 Update

November 14, 2011

Presented to: Citizens Advisory Board

Savannah River Remediation

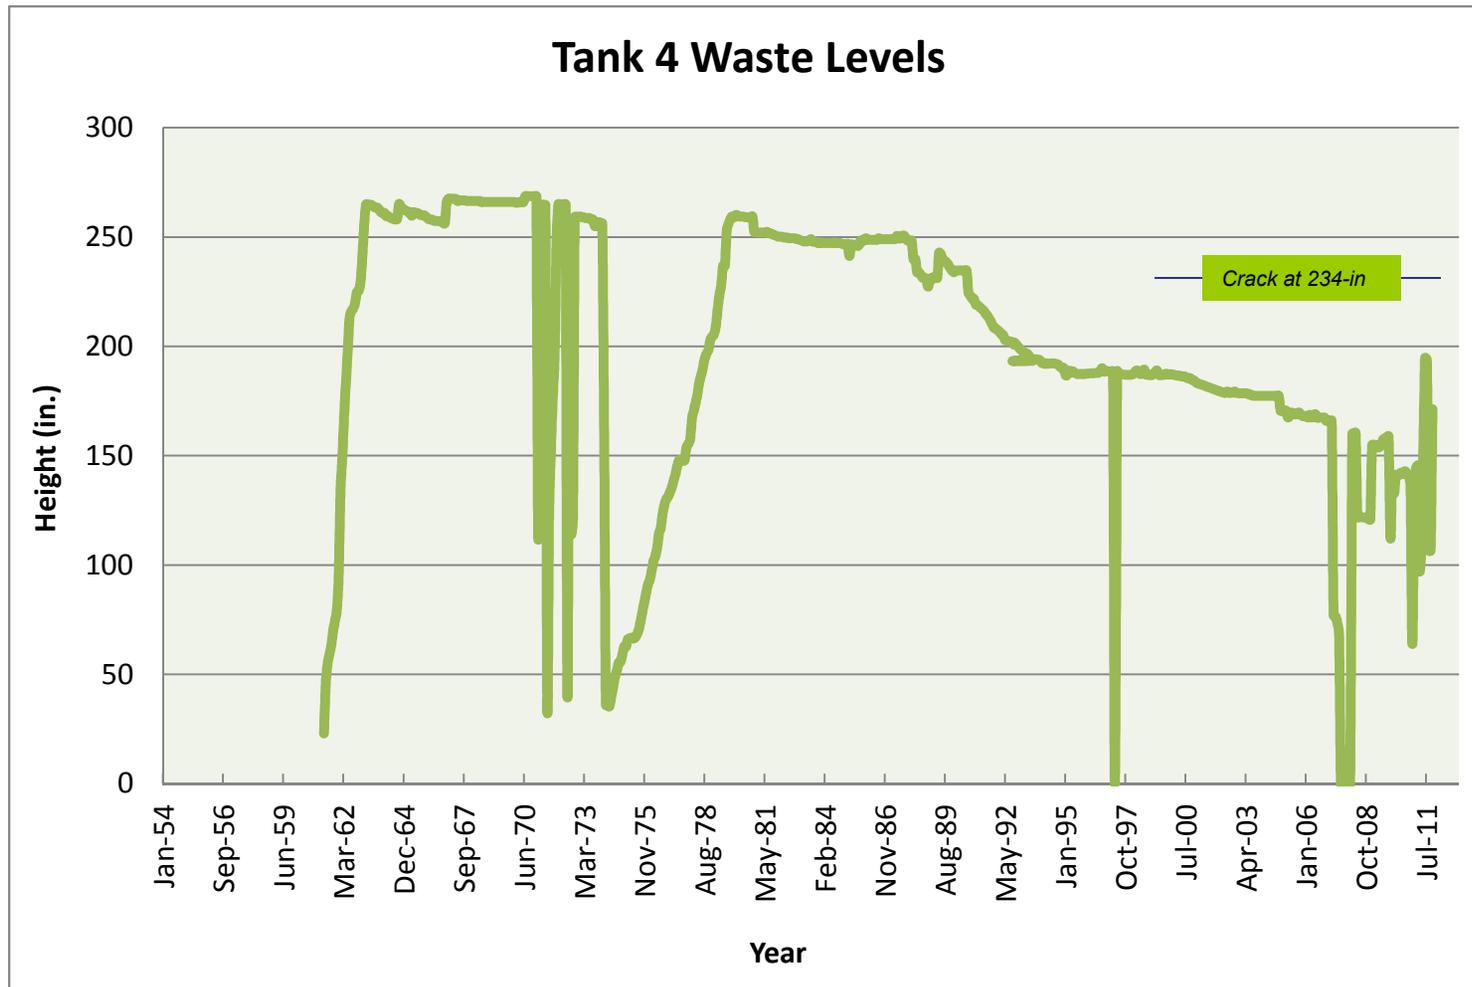
- 2011 inspection photo provided evidence of an indication in the wall of Tank 4, an old-style Type I tank
- After comparison to past photos it was declared a crack
- The operating level for the last 20 years has been below the crack location (234 in).
- The location of the newly identified crack is consistent with our known degradation mechanisms (SCC) for a non heat treated Type I Tank.

- The structural integrity of the tank remains sound with a high margin
- The leak integrity will be maintained by limiting liquid volume below the crack site
- A specific inspection plan will be developed to reduce the risk of leaks in tank 4 during waste removal operations

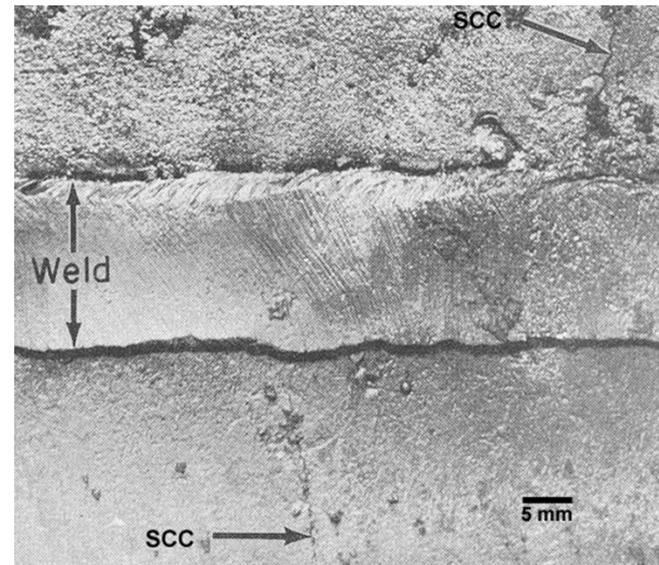
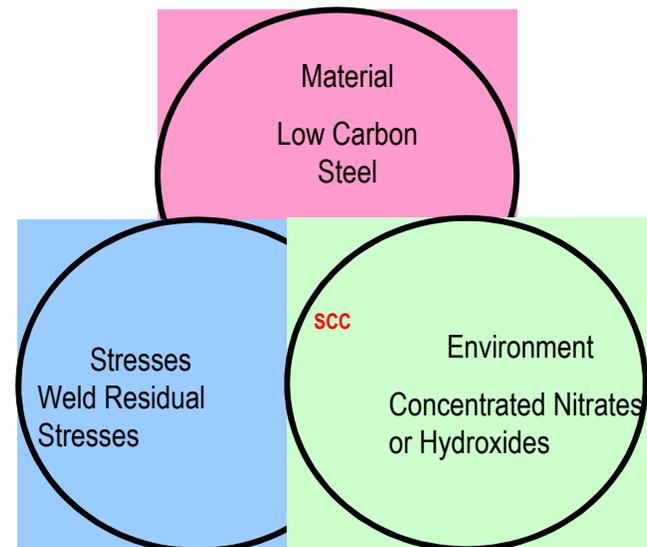
- Primary mode of degradation is nitrate-induced stress corrosion (SCC) cracking near fabrication welds or repair welds
- Occurred early in service in non-stress relieved Type I/II Tanks
- Type III Tanks have no known leaksites
 - Better materials of construction
 - Post-weld heat treatment to relieve weld residual stresses
- Corrosion control program to preclude further degradation
- Corrosion control program has been successful in preventing any liquid leaks
